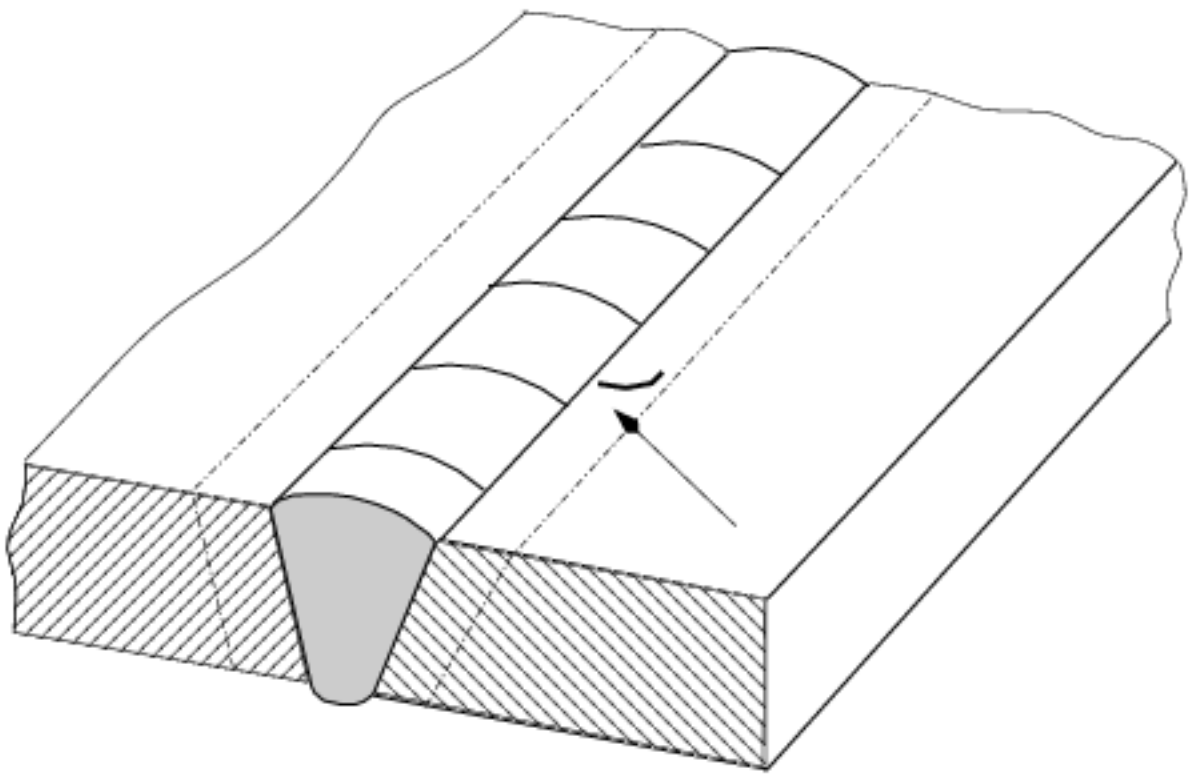
1023 Transverse crack in the heat affected zone
